External over-coating of the glass bath

Michael Horsfield considers the application of external over-coating to the furnace glass bath and the need for continuous monitoring.

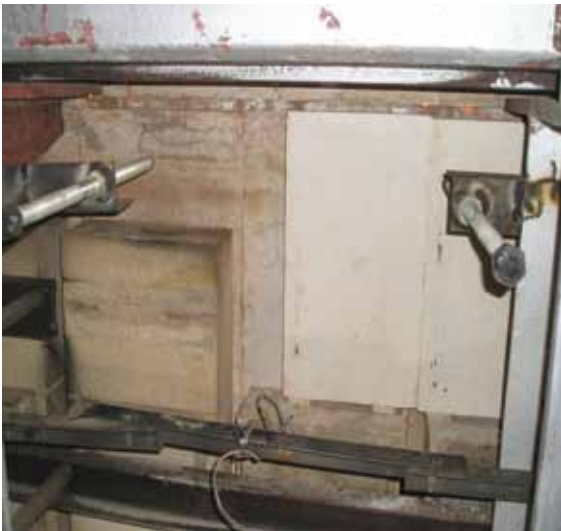
Positioning of metal line over-coat tiles.

Metal line over-coat: During the furnace campaign life, the metal line wears continually with time, at rates that can be variable throughout this period, due to changes in glass output, batch feed characteristics, the efficiency of air and in some cases, water cooling systems, refractory exudation and refractory corrosion.

Because of this wear, the metal line of the glass bath soldier (or sidewall) blocks becomes hot and thin. This, in turn, causes cracking in several directions, forming pieces

which can be pushed outwards with the pressure of the glass behind them.

To prevent glass leakage and unexpected breakage of the refractory, the position is externally over-coated.

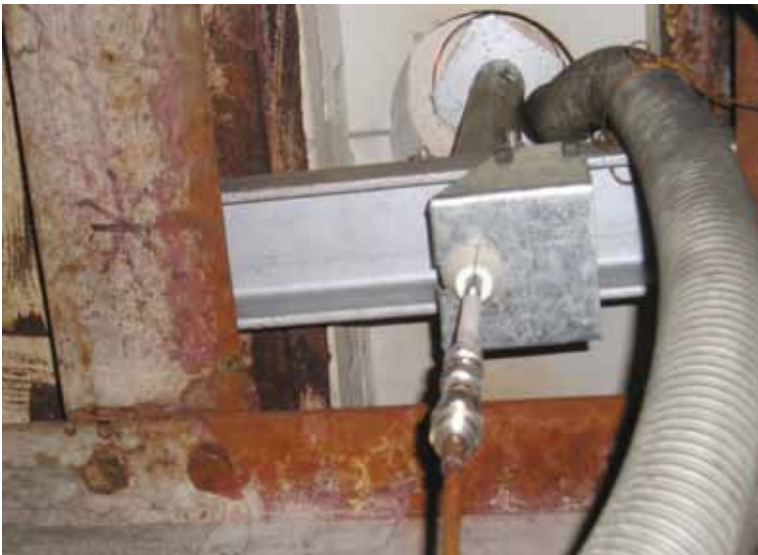
Bubbler block over-coat tile supported in position.

Bottom over-coat: Certain observed glass bath bottom conditions, including hot refractory, cracking of electrode and bubbler blocks and glass leakage may give cause to over-coating a local position to prevent an adverse condition and aid structural stability during a given furnace campaign life.
